**Jorgensen Forge Outfall Site
Seattle, Washington**

**Source Control Action
Completion Report**

Prepared by
FLOYD | SNIDER
601 Union Street
Suite 600
Seattle, Washington 98101

May 27, 2011

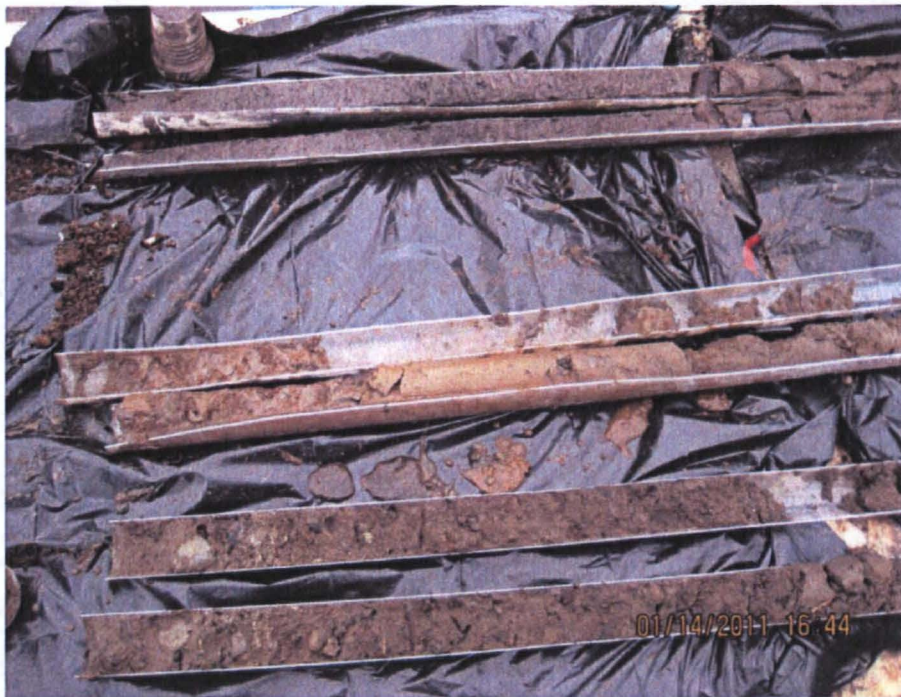
Photo 1. Cores collected from 0–15 feet from Boring T1B1.

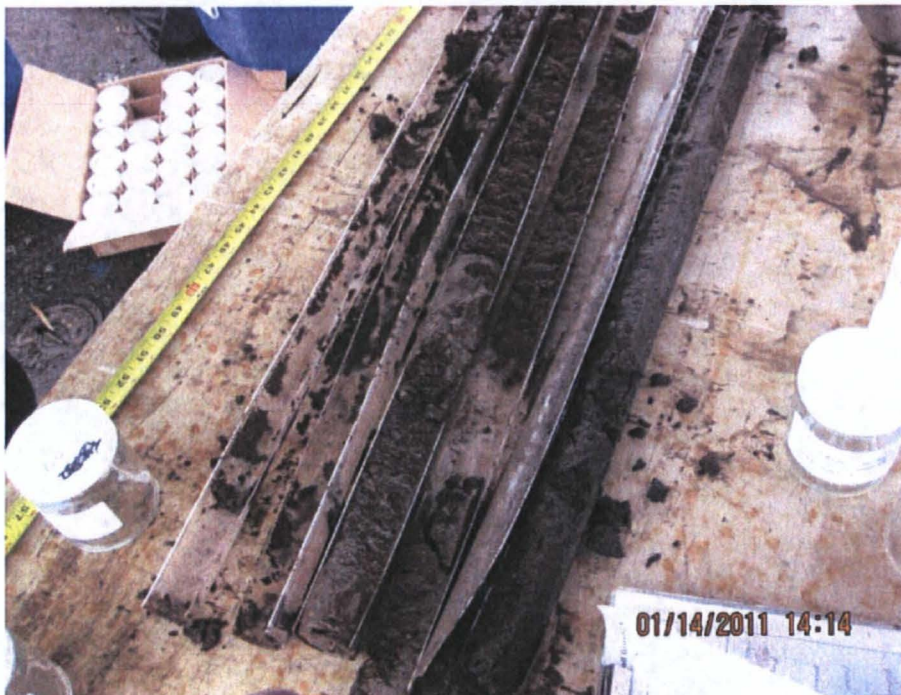
Photo 2. Cores collected from 0–15 feet Boring T1B2.

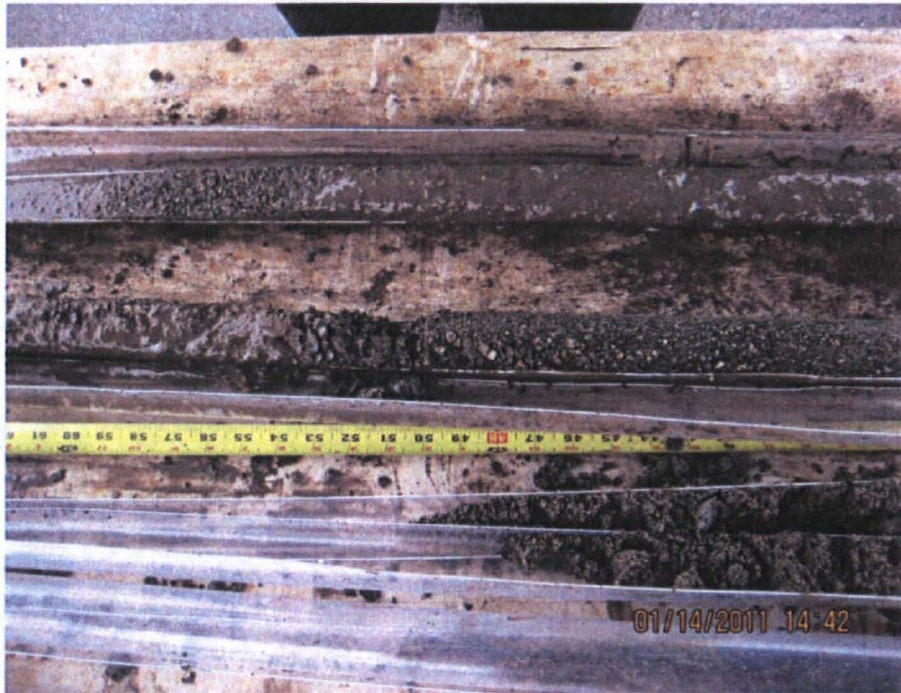
Photo 3. Cores collected from 0–20 feet from Boring T1B3.
Note poor recovery of some intervals.

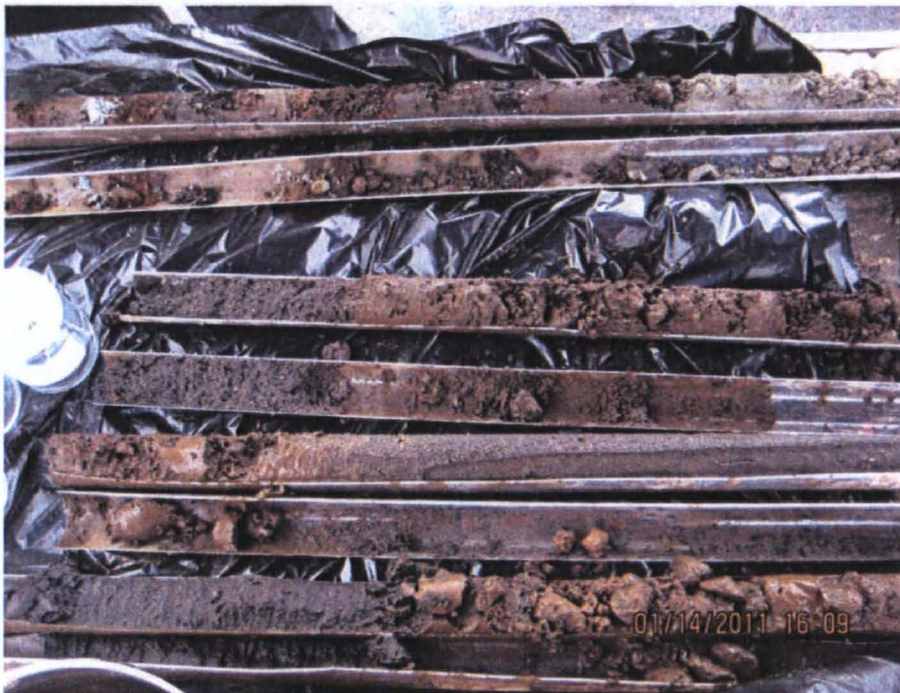
Photo 4. Cores collected from 0–20 feet Boring T1B4.

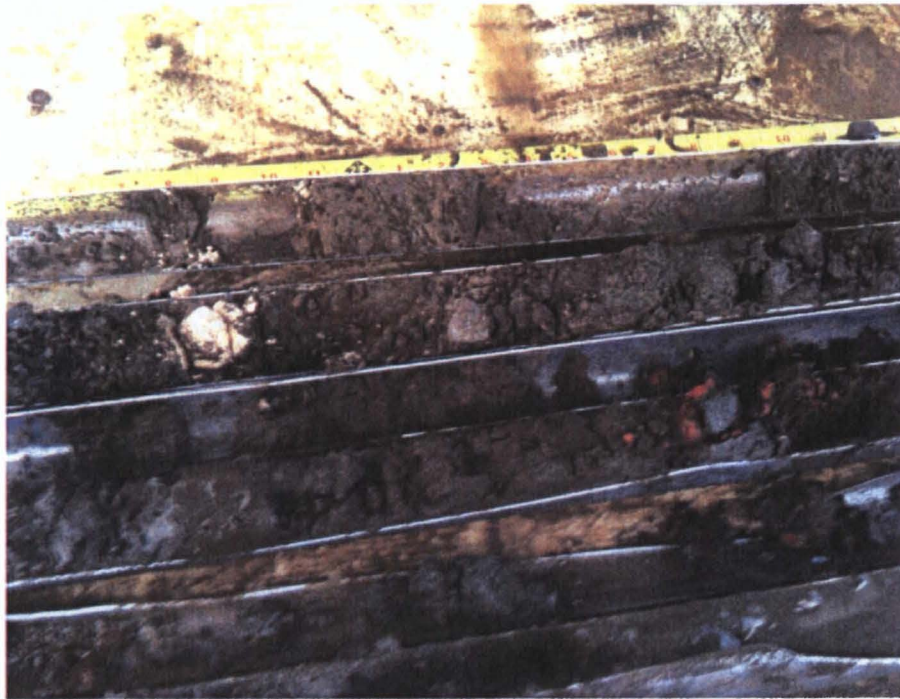
Photo 5. Cores collected from Boring 0-15 from T2B2. Note prevalence of debris fill.

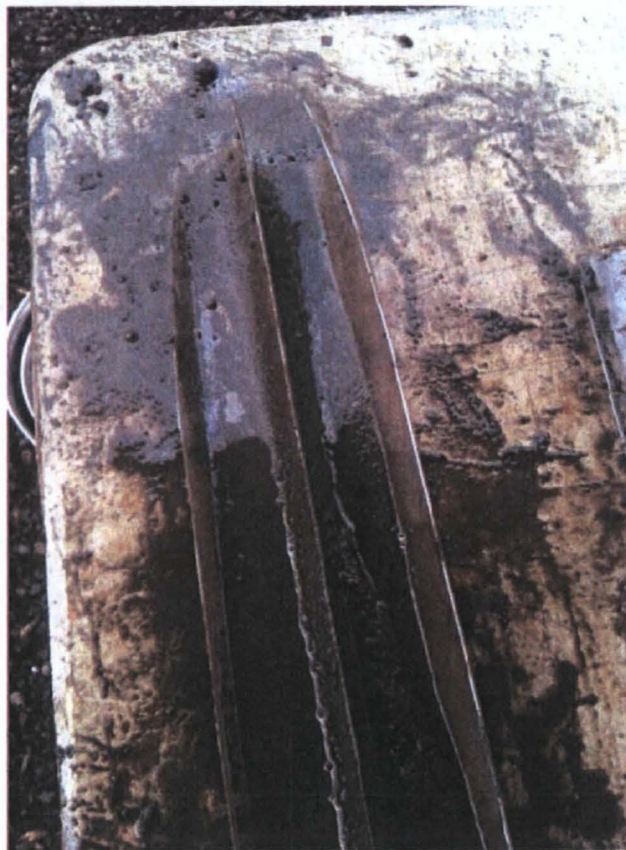
Photo 6. Sheen noted in 16-20 foot interval core collected from Boring T2B4.

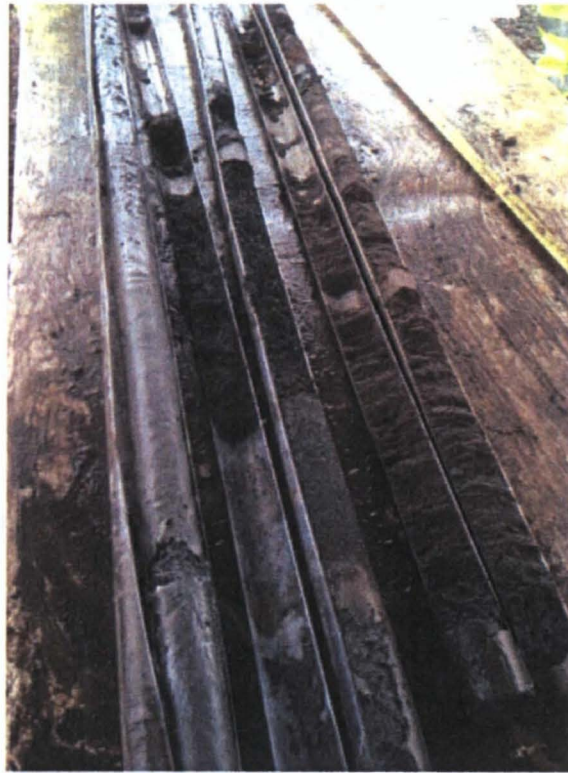
Photo 7. View of the three cores collected from 0–15 feet at Boring T3B1.

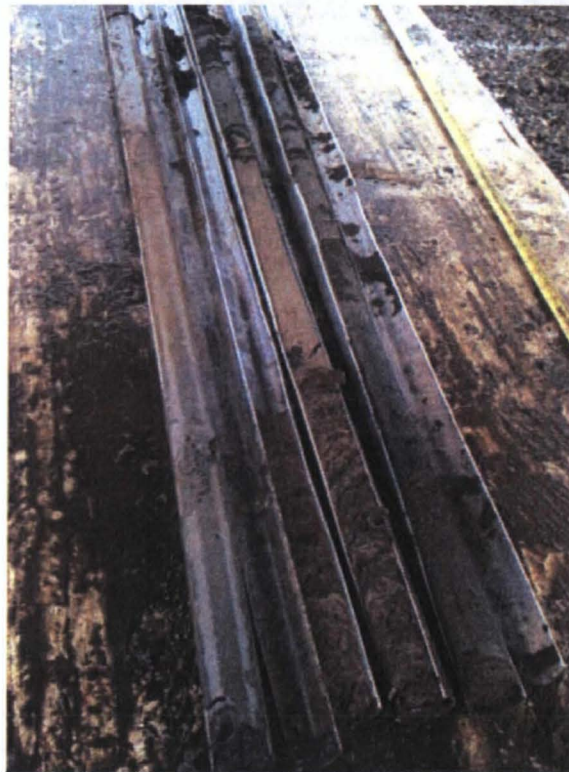
Photo 8. View of cores collected from 0–15 feet at Boring T3B2.

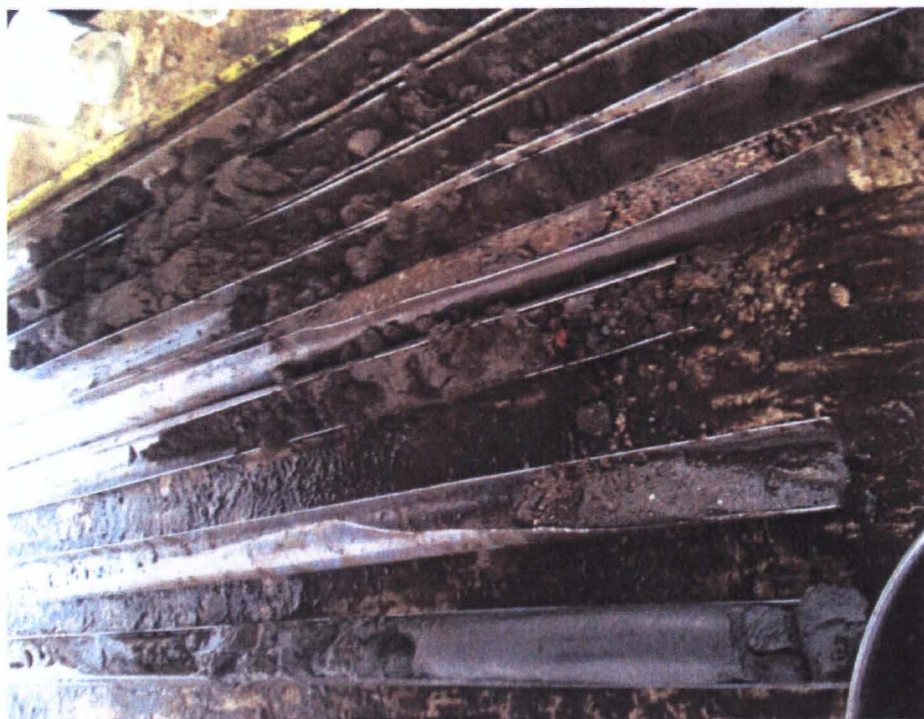
Photo 9. View of three spilt cores collected from Boring T3B3 from 0–15 feet.

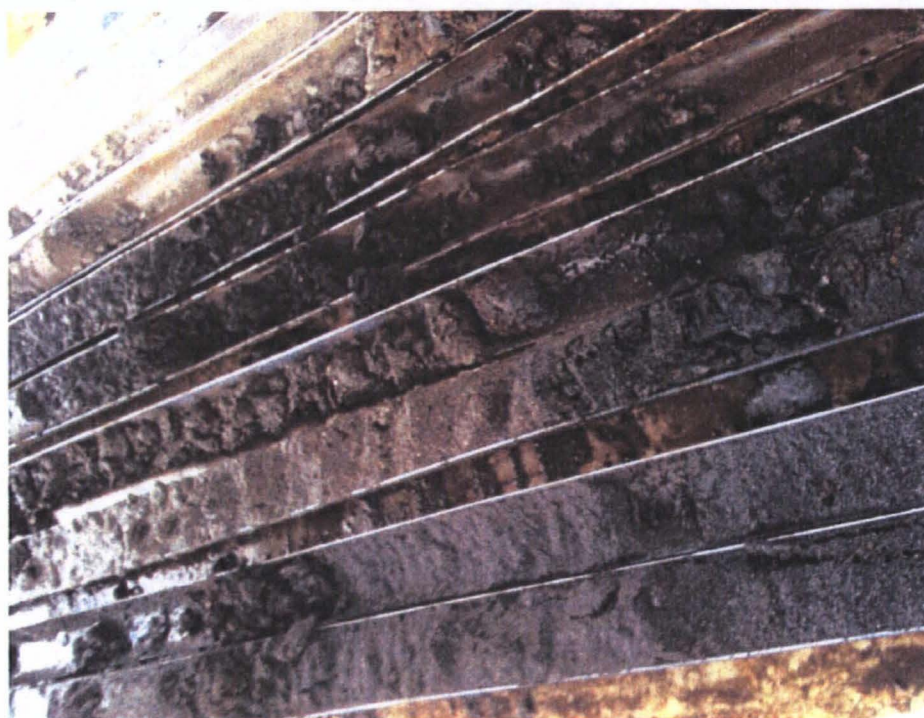
Photo 10. View of cores collected from Boring 5 to 25' feet at Boring T3B4.

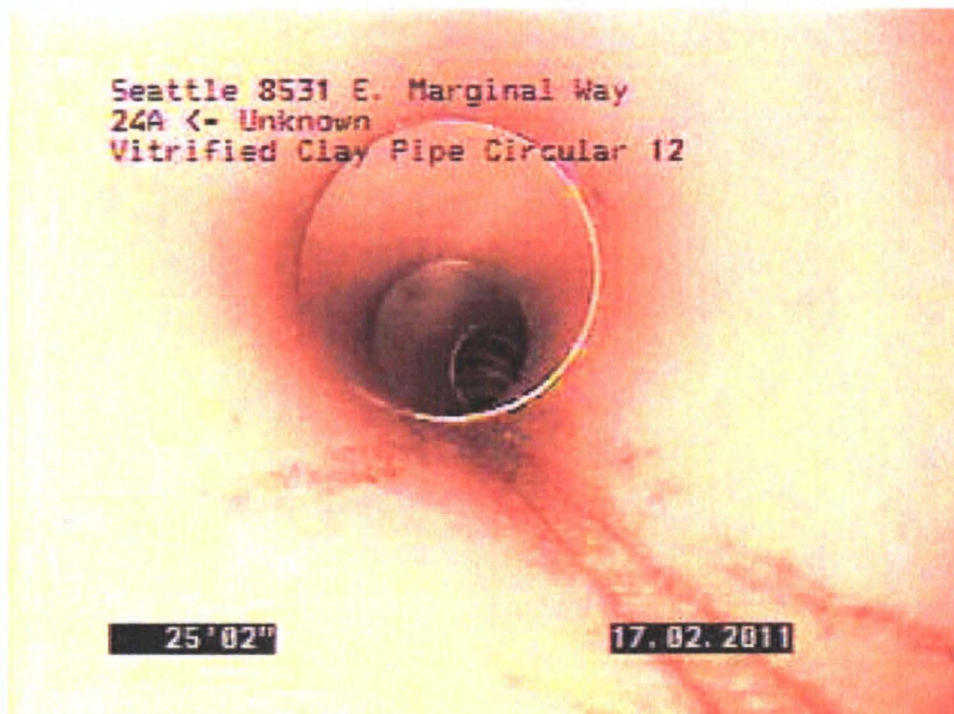
Photo 22. View of upgradient seal within Jorgensen 10-inch Lateral looking upstream from first bend in pipe, approximately 25 feet upgradient from connection to 24-inch Pipe.

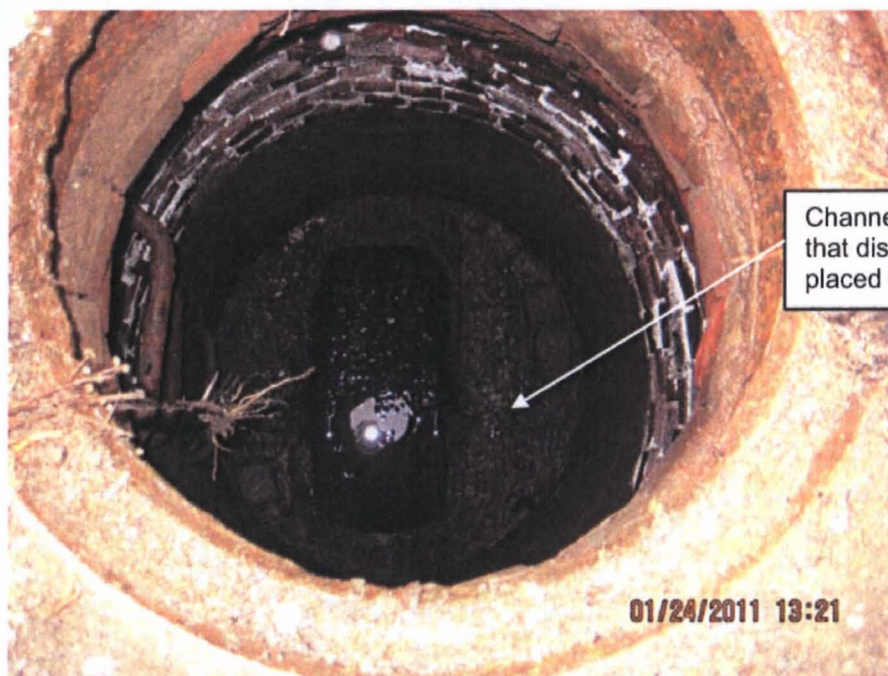
Photo 23. View of SDMH 24A and 24-inch Pipe from surface.
(Photo taken during pre-cleaning inspection.)

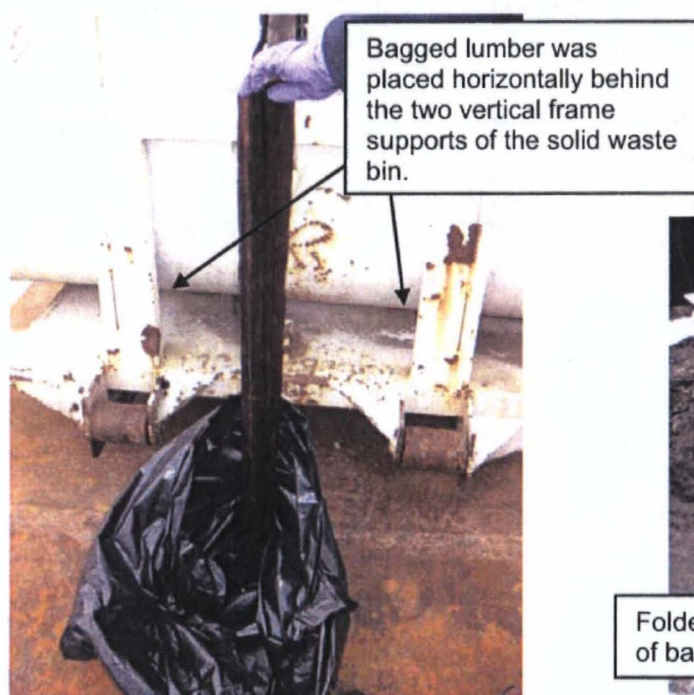
Photo 24. Lumber retrieved from SDMH 24A February 18, 2011.
(Source: Anchor QEA, LLC 2011)

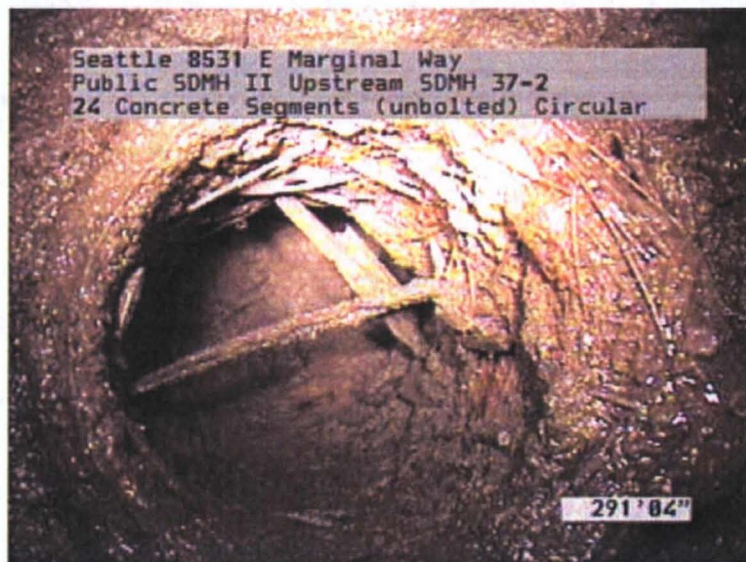
- As previously described, a new lateral was discovered in the location of the Jorgensen northeast visitor parking area. The lateral is a 4-inch cast iron pipe that entered the top of the 24-inch Pipe. The lateral was observed to be plugged with soil. A video inspection of the 4-inch lateral was conducted again on February 14, 2011 after the upgradient portion of the pipe had been excavated from the parking area and jetted to remove soil that fell into the lateral upon excavation. The additional inspection revealed that the lateral rose up and made an immediate bend to the south several inches above its point of connection in the 24-inch Pipe and then went vertical terminating approximately 12 inches bgs.

Photo 28. View of Jorgensen Visitor Parking Area 4-inch Lateral from within 24-inch Pipe during pre-cleaning video inspection.

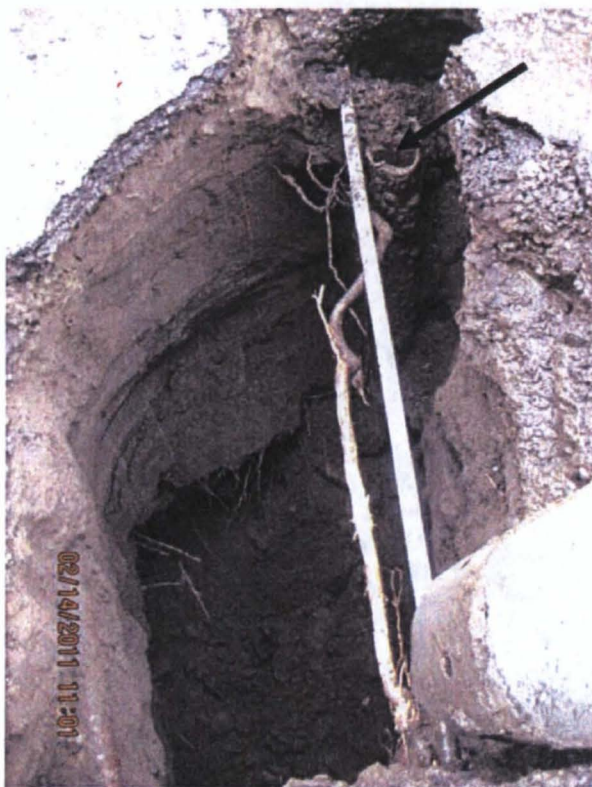
Photo 29. Hydro-excavation of Jorgensen Visitor Parking Area 4-inch Lateral. Arrow indicates broken top of lateral.

The Jorgensen Visitor Parking Area 4-inch Lateral was first exposed by hydrovacuuming, which used high pressure to loosen soil followed by vacuuming to remove the soil. Once exposed, the 4-inch lateral was found to extend vertically to an elevation just below the ground surface where it appeared to have been broken off (jagged edge on end of lateral). No cap or seal was present on the upgradient end. The 4-inch lateral was then cleaned by feeding the power washer nozzle into the top (upgradient) of the exposed lateral and flushed with recycled wash water (refer to Section 2.8.1). The amount of solid material flushed from the lateral is assumed to be very small and consisted of a small plug of soil where the pipe was broken off just under the surface and a

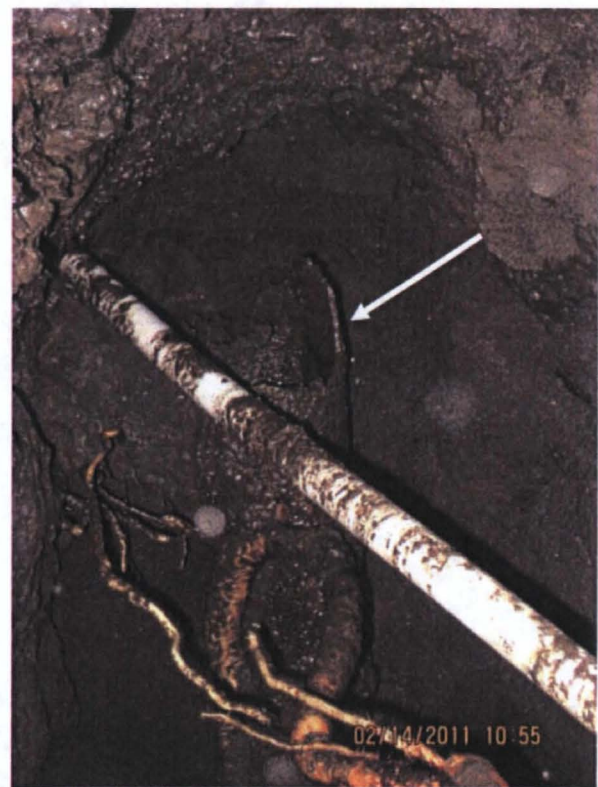
Photo 30. Close up of broken top of Jorgensen Visitor Parking Area 4-inch Lateral (arrow). White pipe is irrigation line.

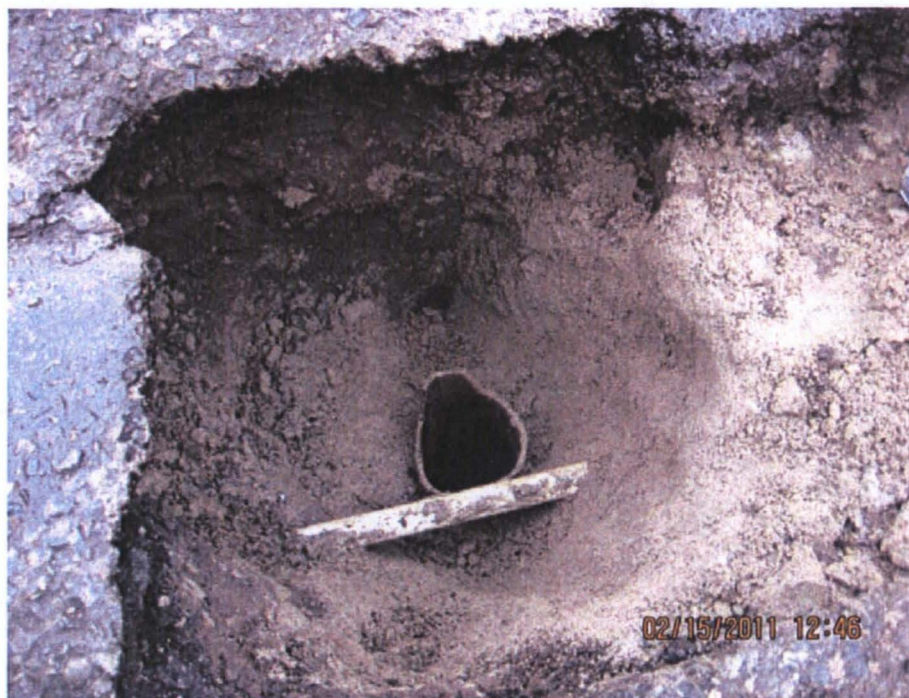
Photo 31. Excavation of Jorgensen Visitor Parking Area 4-inch Lateral backfilled with CDF.

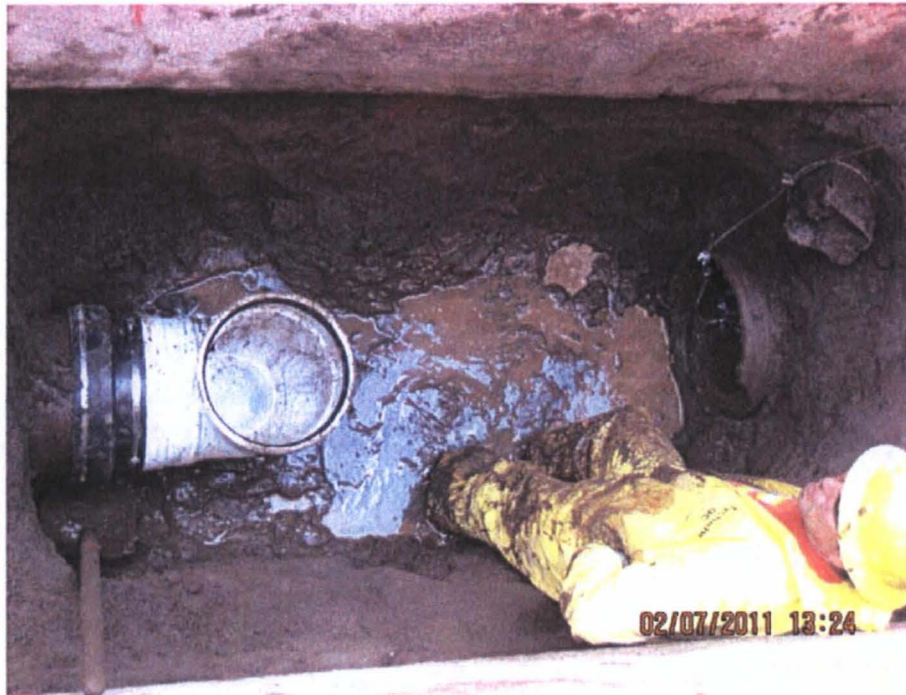
Photo 35. View of section of 12-inch Pipe removed at CMP transition and attachment of cleanout. East is to left.

To prevent influx of tidal waters from entering the clay sections of the Pipes, seals were placed at the transition point between the CMP and clay sections of each pipe (Figure 2). This was done by excavating with a trench box atop the transition point. The excavated soil was stockpiled for backfill. Once the transition of each pipe was uncovered, a short section of clay pipe, approximately 3 feet long, was removed at the joint closest to the CMP. An inflatable buoy was placed into the open CMP stub and secured to an iron beam that was found lying perpendicular to the Pipes above the transition point. Several bolts were drilled into the stub for concrete reinforcement and quick-setting concrete was packed into the opening until flush with the stub.

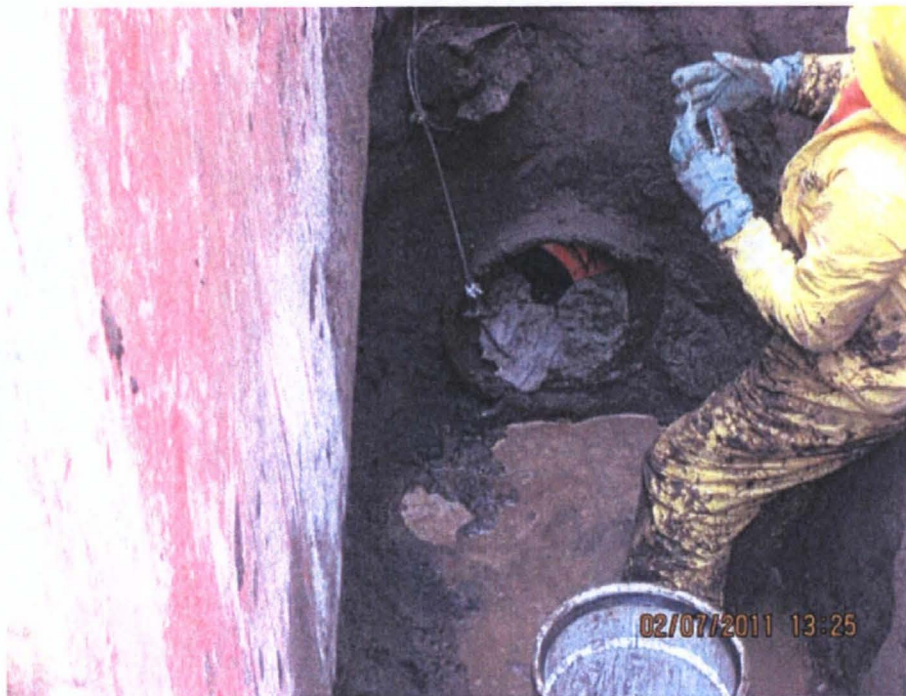
Photo 36. Placement of seal in 12-inch Pipe at CMP transition. Photo taken looking west.

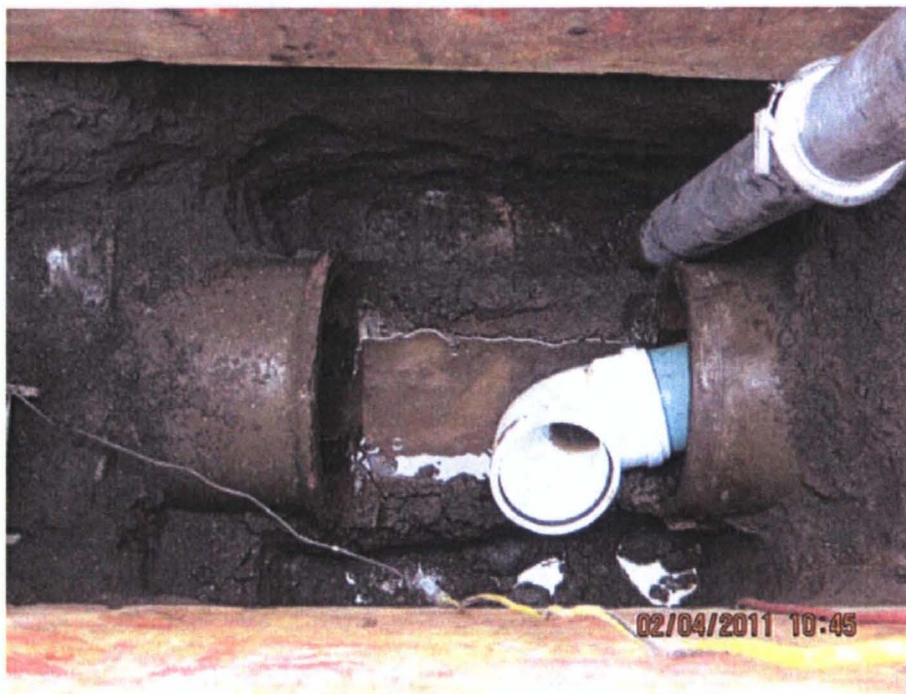
Photo 38. Section of 24-inch Pipe removed at CMP transition.

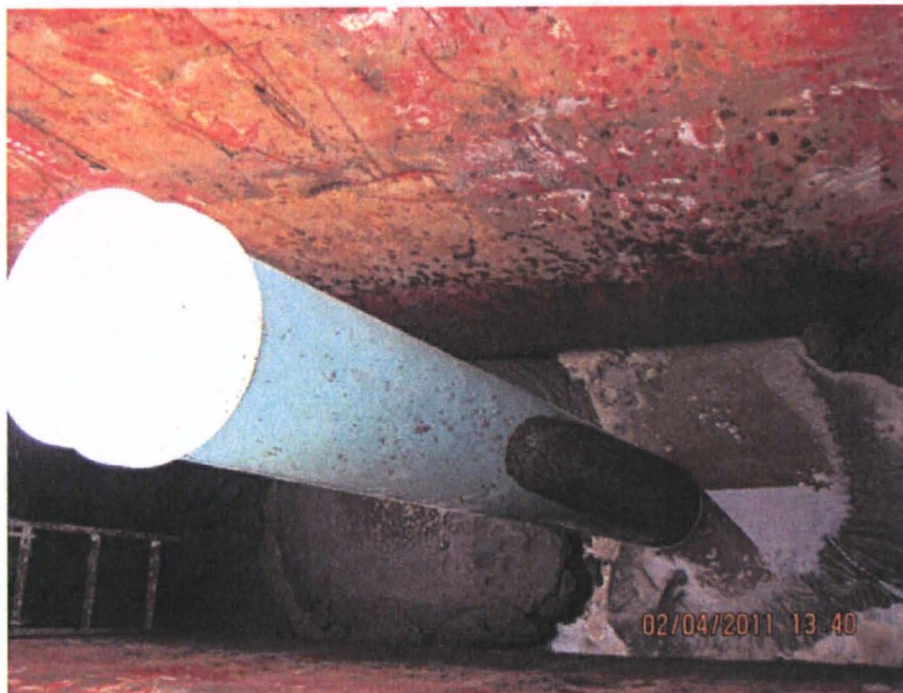
Photo 40. View of seal and cleanout placed in 24-inch Pipe at CMP transition and backfilling excavation with CDF.

On the open end of each clay pipe, a 12-inch PVC riser pipe was installed to facilitate the cleaning activities. To attach a riser to the 24-inch Pipe, a 90-degree elbow was first secured to the pipe with concrete, and for the 12-inch Pipe, an elbow was secured using a compression collar. A vertical standpipe approximately 10 feet long was fit to each elbow. When the downgradient seal and riser were in place, the excavation was backfilled with approximately 3 feet of CDF and the stockpiled excavated soil was replaced in similar sequence as it was removed (i.e., "first out, last in").

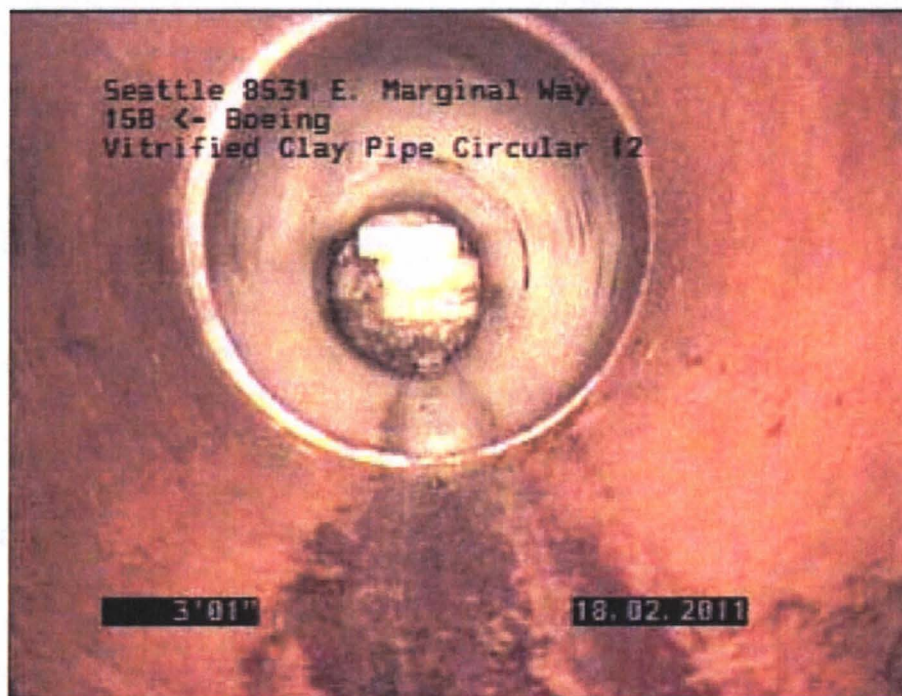
Photo 42. Post-cleaning view of existing upgradient seal of 12-inch Pipe from approximately 3 feet upgradient from SDMH 15B.

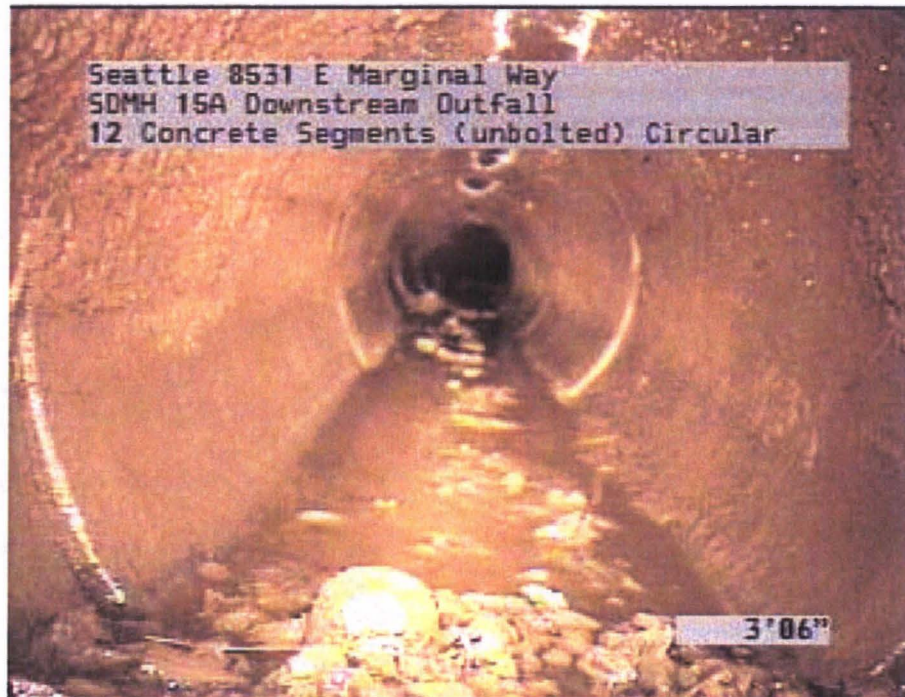
Photo 43. Pre-cleaning view looking downstream from approximately 3 feet downgradient from SDMH 15A.

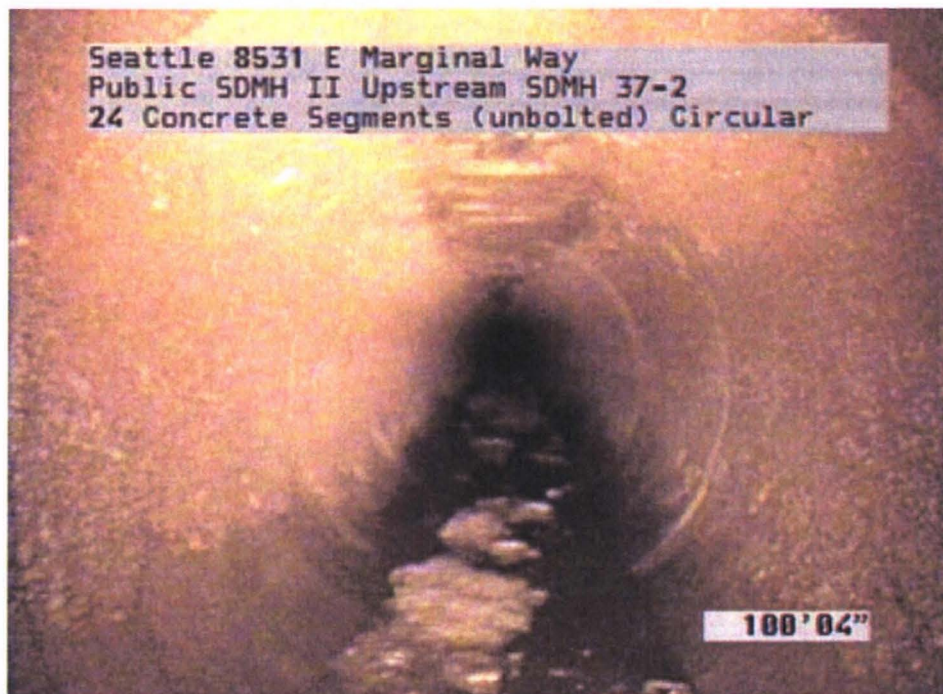
Photo 45. Pre-cleaning view of 24-inch Pipe looking upstream from approximately 100 feet upgradient of SDMH 37-2.

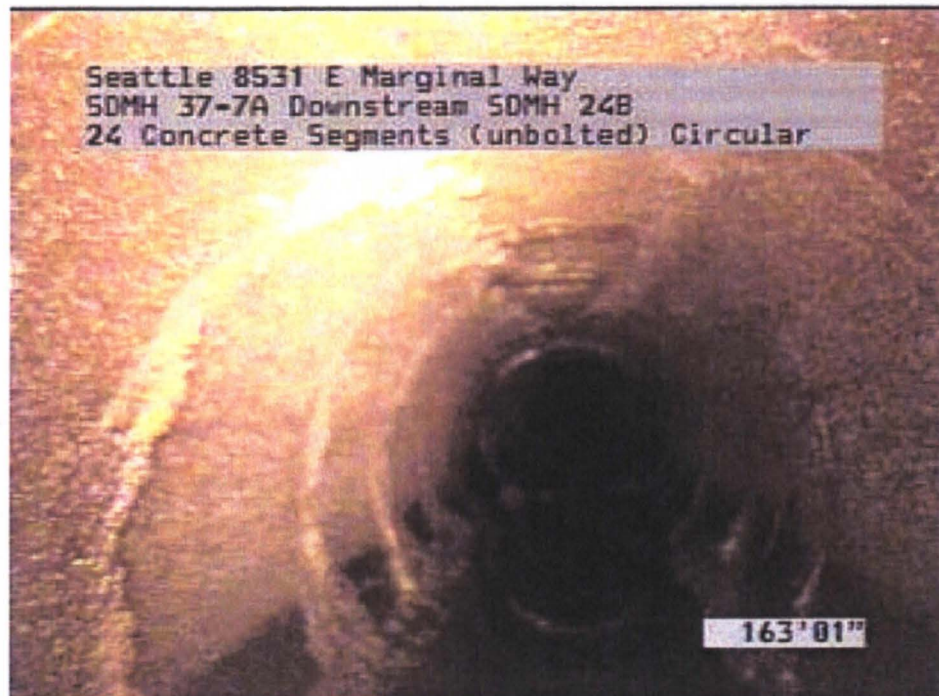
Photo 47. Pre-cleaning view of 24-inch Pipe looking downstream from approximately 163 feet downgradient of SDMH 37.7.

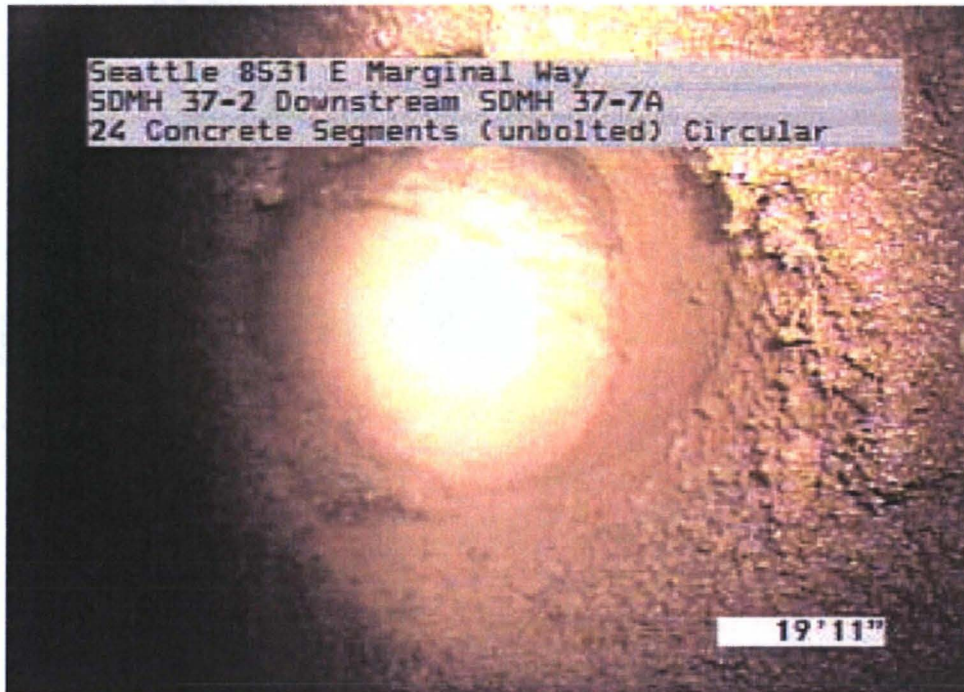
- As previously described, a factory cap seal was confirmed to be intact at the entry point of the lateral into the 24-inch Pipe near the Jorgensen office. No evidence of liquid or solid material was observed around the cap.

Photo 49. View of factory cap on Jorgensen office lateral during pre-cleaning inspection from approximately 19 feet downgradient of SDMH 37-2.

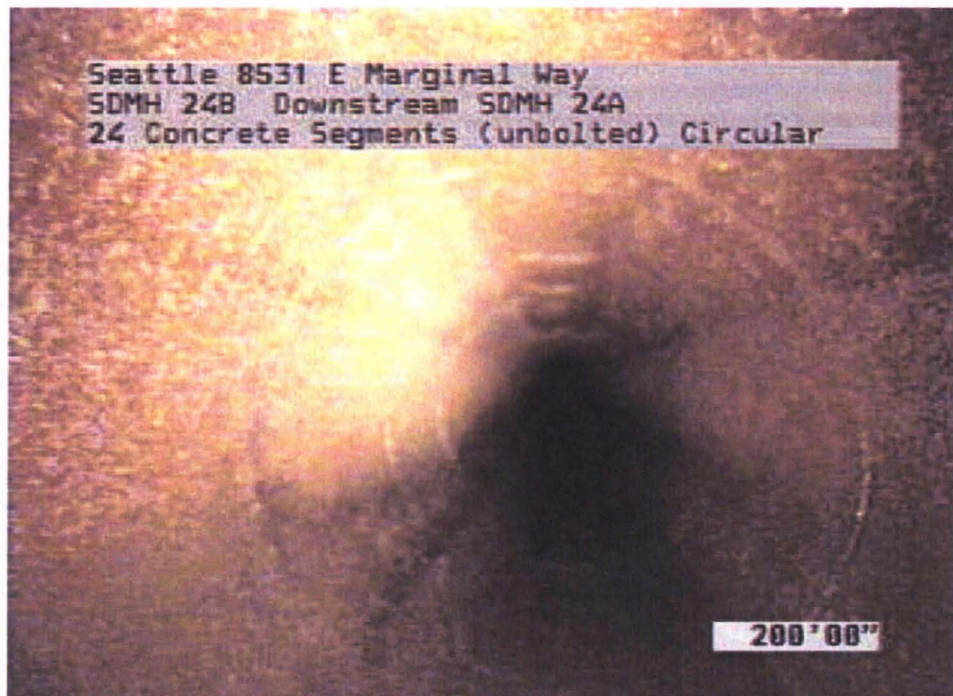
Photo 50. Pre-cleaning view of 24-inch Pipe looking downstream from approximately 200 feet downgradient of SDMH 24B.

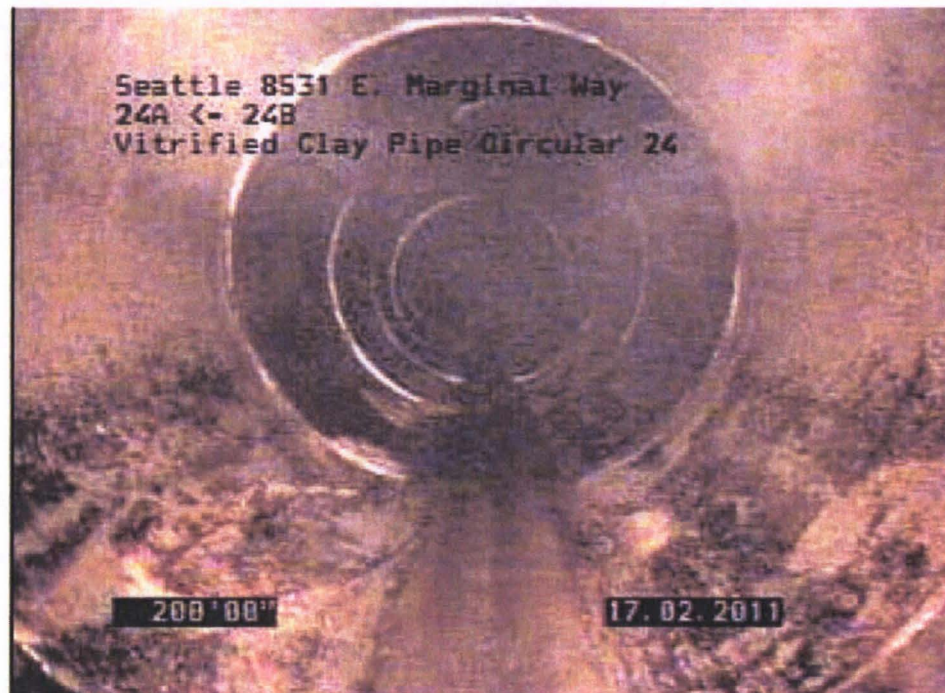
Photo 51. Post-cleaning view of 24-inch Pipe looking downstream from approximately 200 feet downgradient of SDMH 24B.

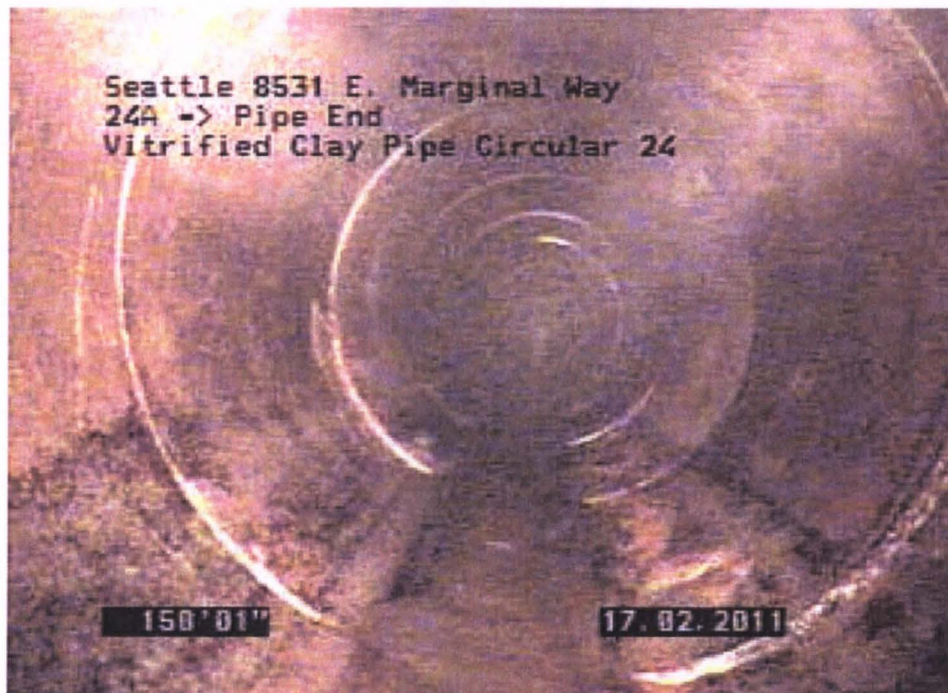
Photo 53. Post-cleaning view of 24-inch Pipe looking downstream from approximately 150 feet downgradient of SDMH 24A.

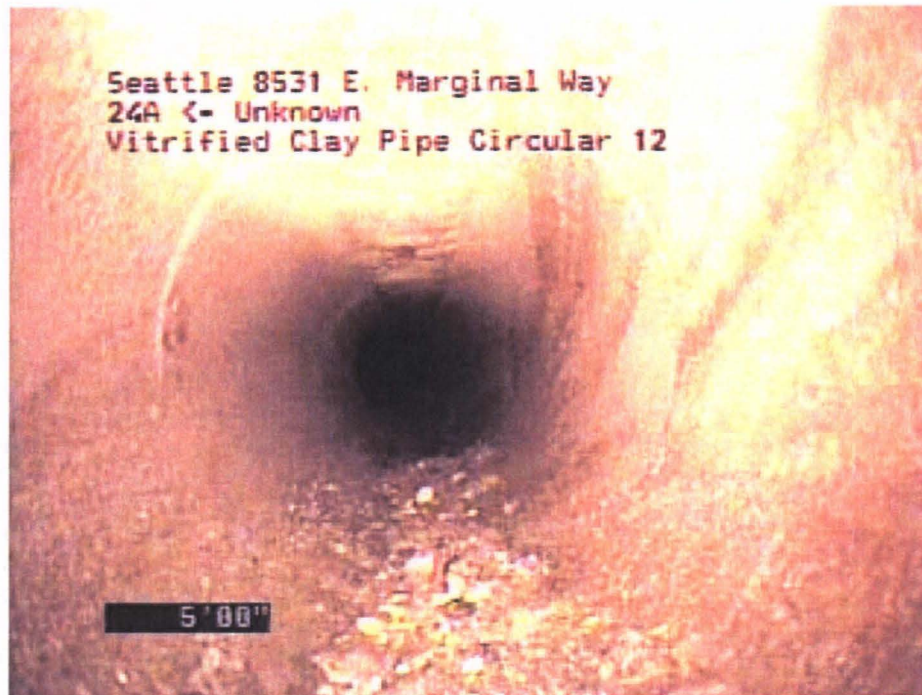
Photo 54. Pre-cleaning view of Jorgensen 10-inch Lateral looking upstream from approximately 5 feet upgradient from connection to 24-inch Pipe.

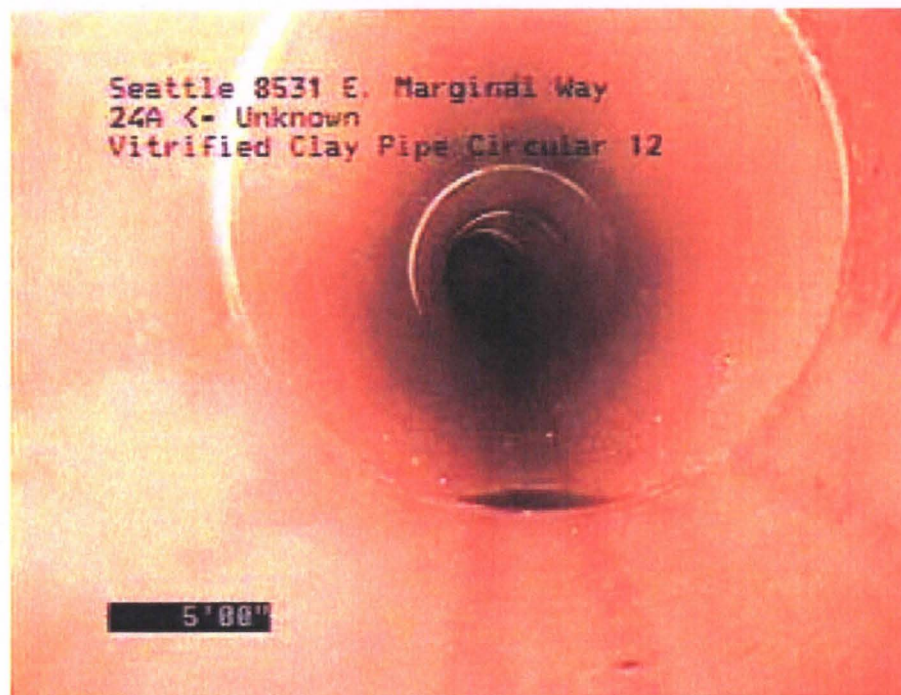
Photo 55. Post-cleaning view of Jorgensen 10-inch Lateral looking upstream from approximately 5 feet upgradient from connection to 24-inch Pipe.

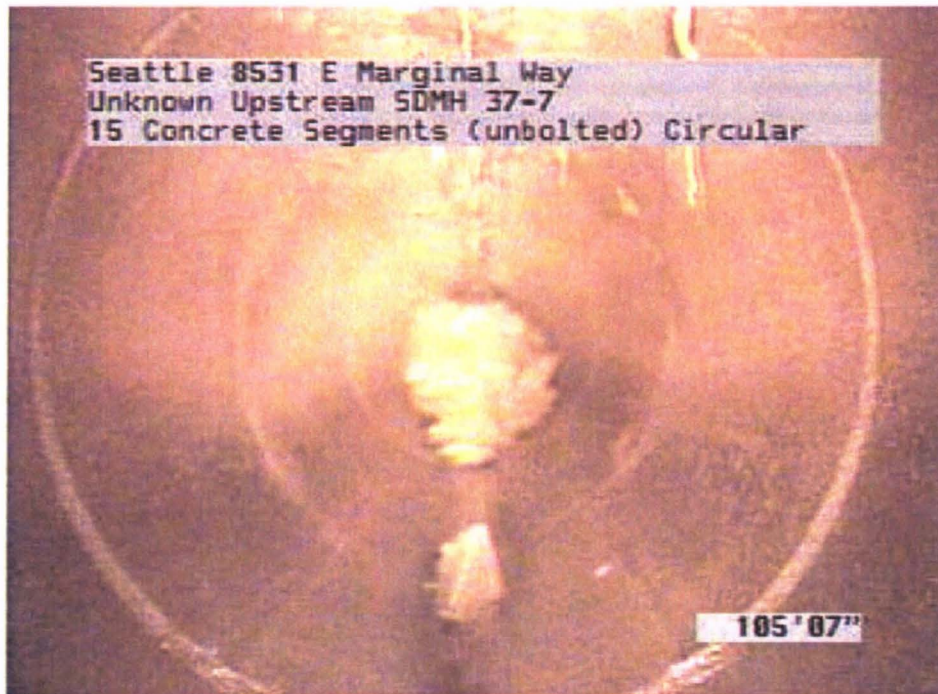
Photo 56. Pre-cleaning view of Boeing 15-inch Lateral looking upstream from approximately 10 feet from upgradient seal.

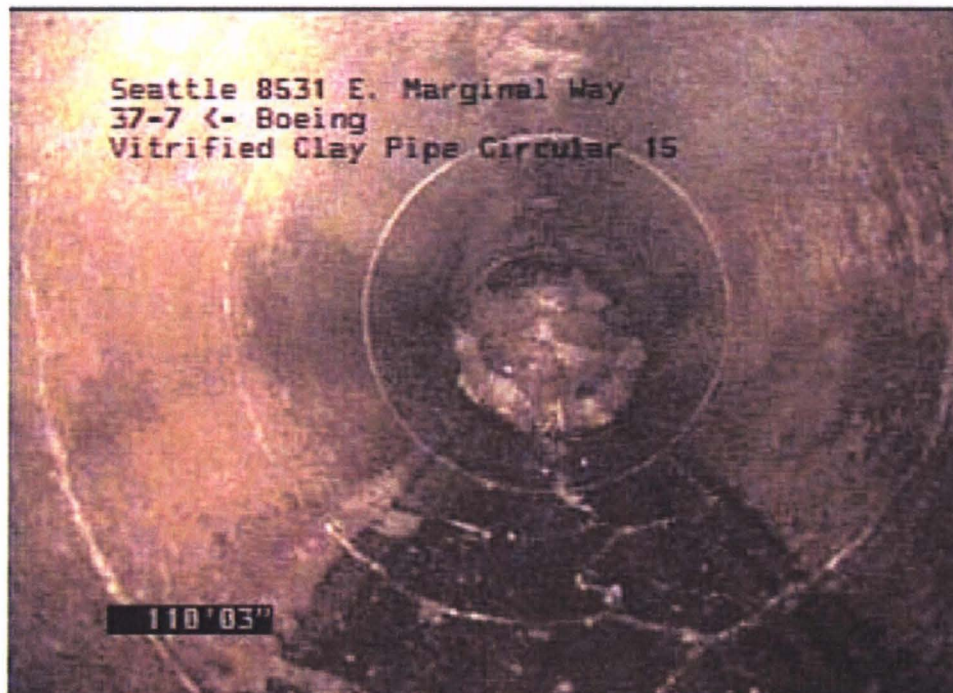
Photo 57. Post-cleaning view of Boeing 15-inch Lateral looking upstream from approximately 10 feet from upgradient seal.

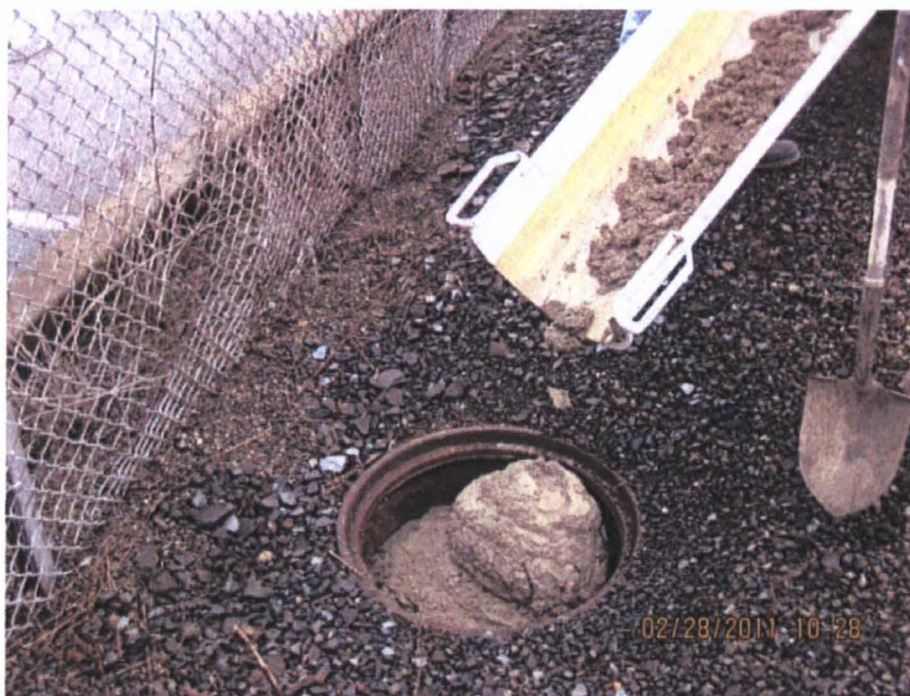
Photo 60. Manhole sealed with CDF.

Following cleaning of the pipes, the manholes were sealed in accordance with the work plan. Location of the seals is noted on Figure 2. The method used to seal each location is described below. Photographs are also provided in Appendix C.

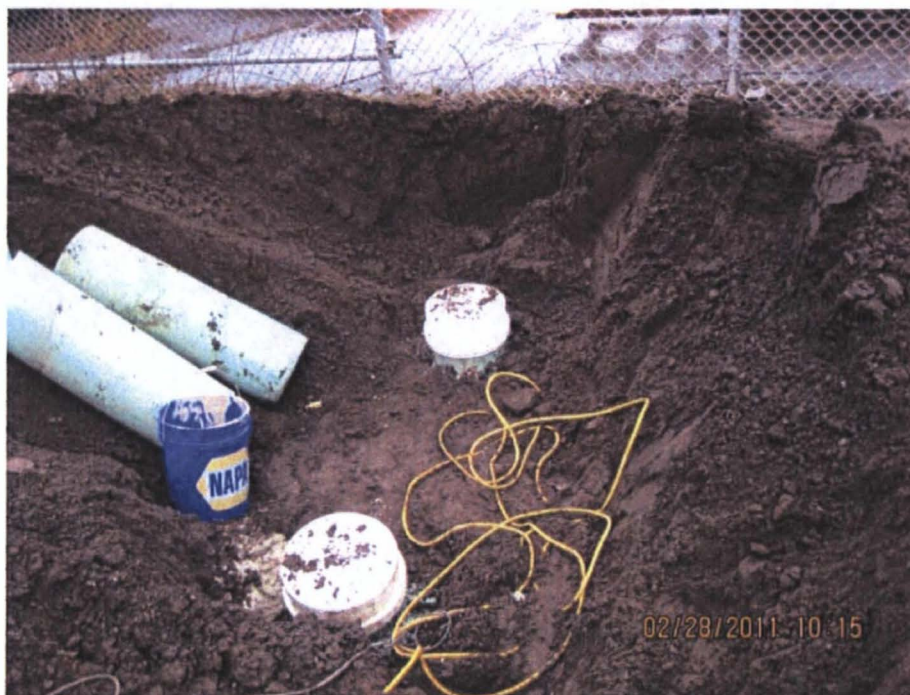
Photo 61. Cleanouts at CMP transition sealed.
